DEZINCIFICATION OF COPPER ALLOYS IMPELLERS USED FOR POTABLE WATER PUMPING

M. Rotel*, R. Starostin*, S. Tamir* and P. Letai**

*** Israel Institute of Metals, Technion R&D ltd., Israel**

**** Mekorot, Water Co. Ltd.**

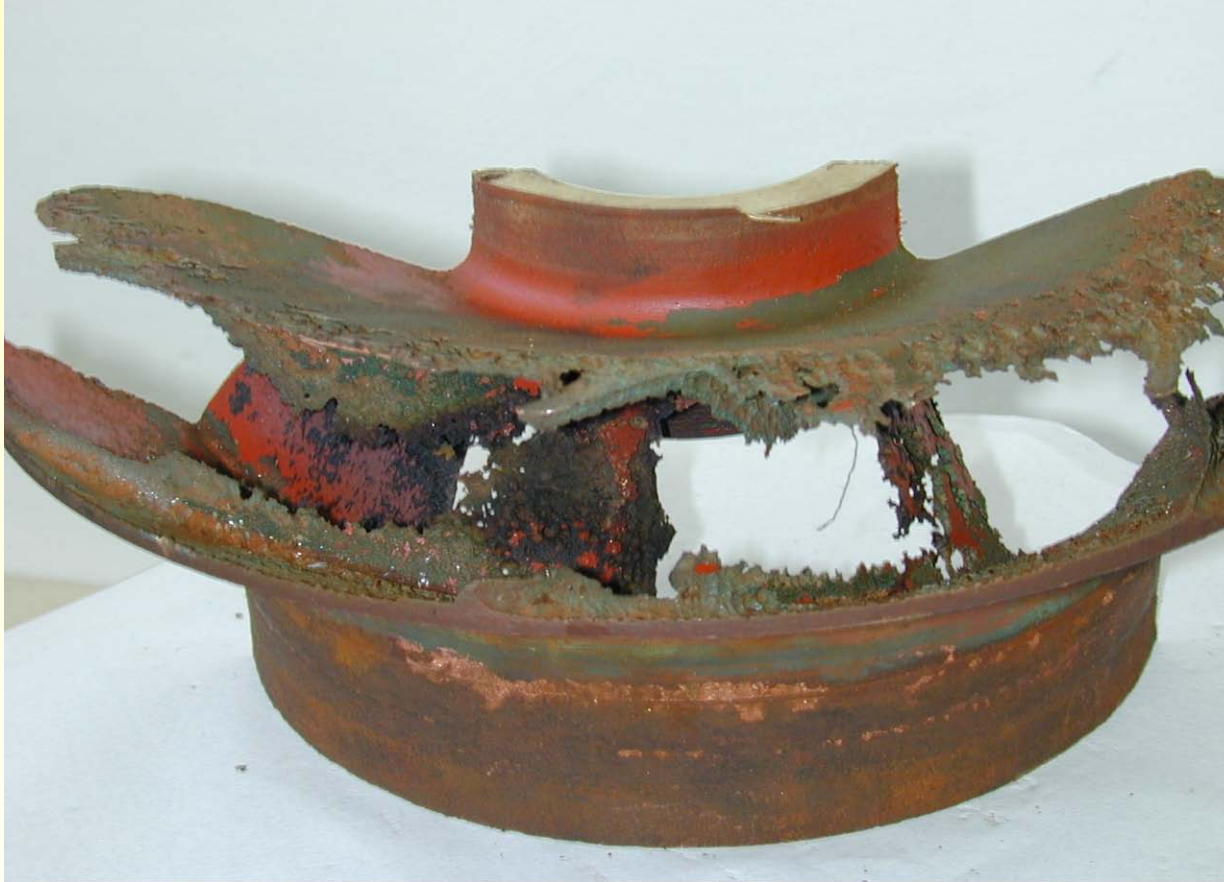
UNS C87600: Zn 6.6%, Si 3.8%

Corroded Impeller

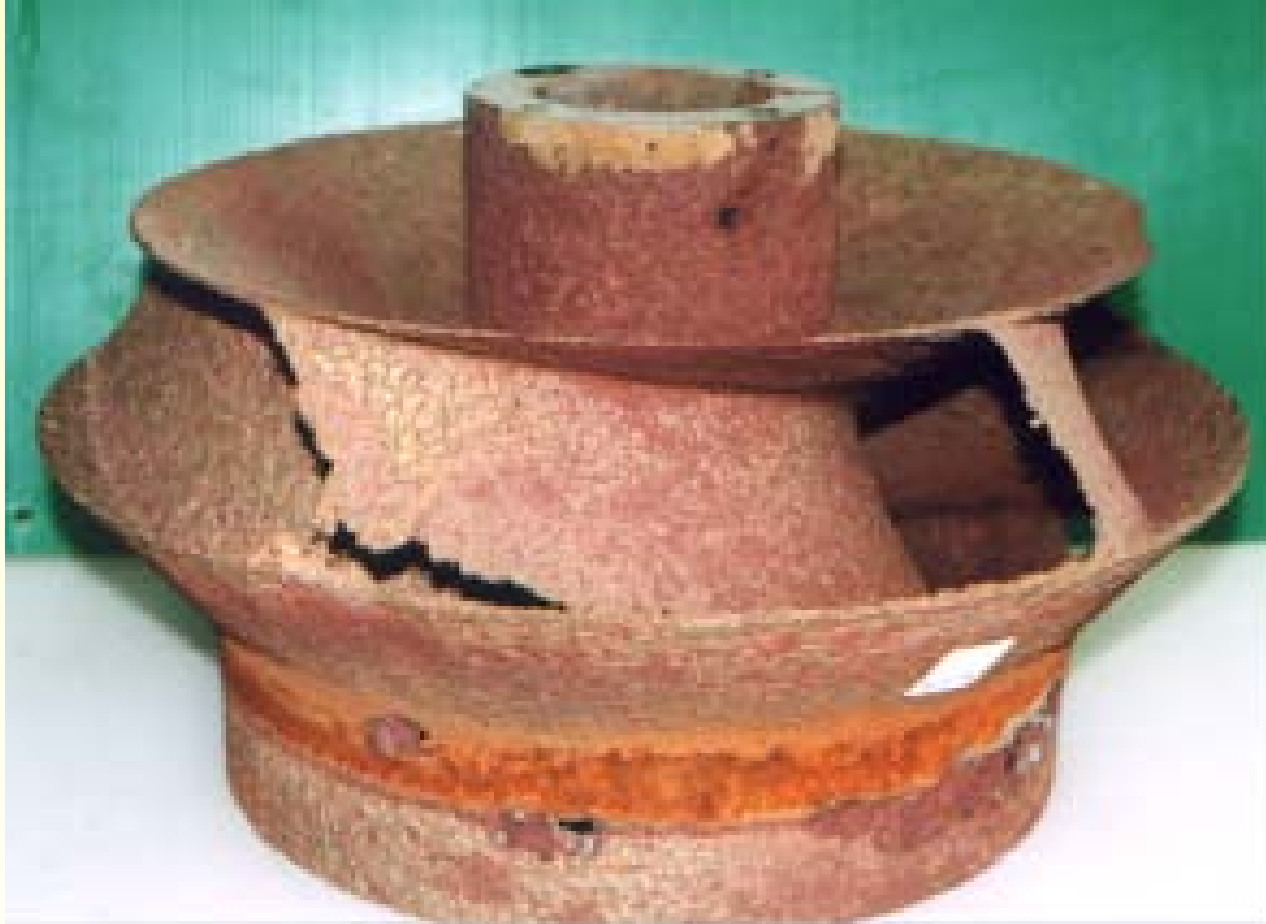
UNS C87500: 14.6%Zn, 3.75%Si

Corroded Impeller

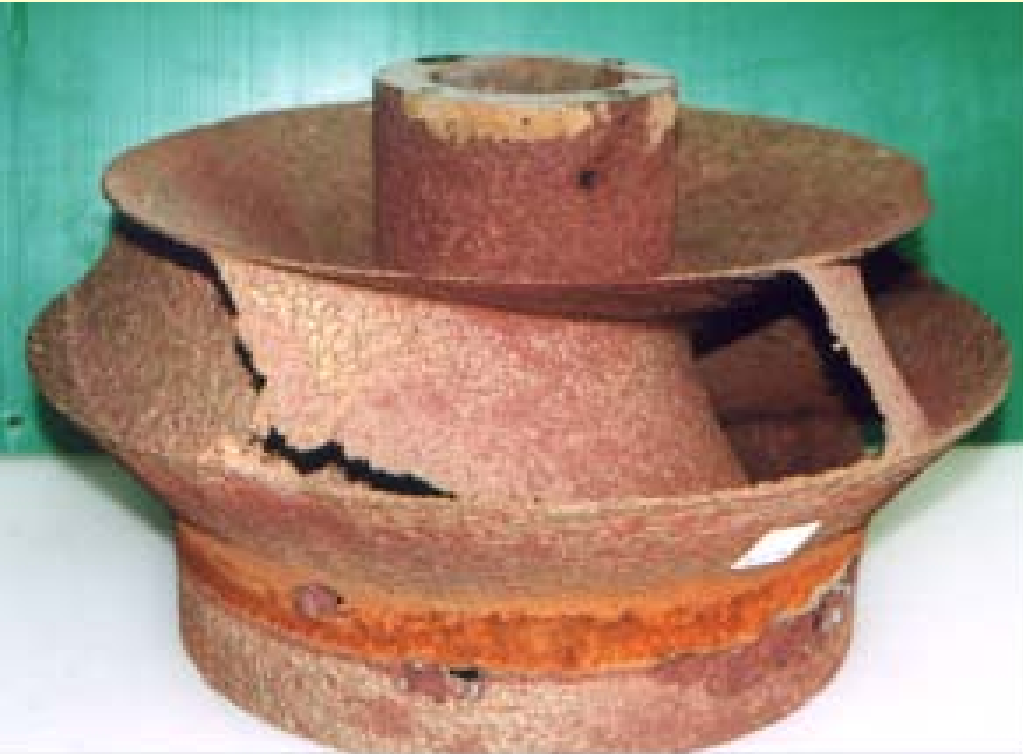
UNS C87500: 14.6%Zn, 3.75%Si

Corroded Impellers

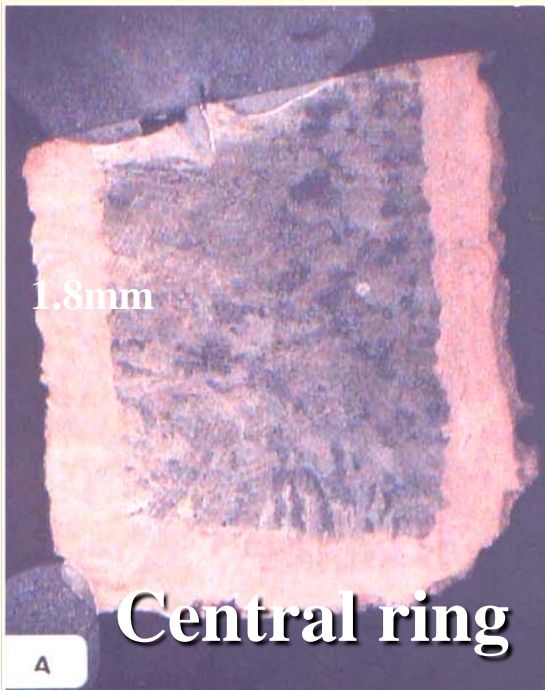
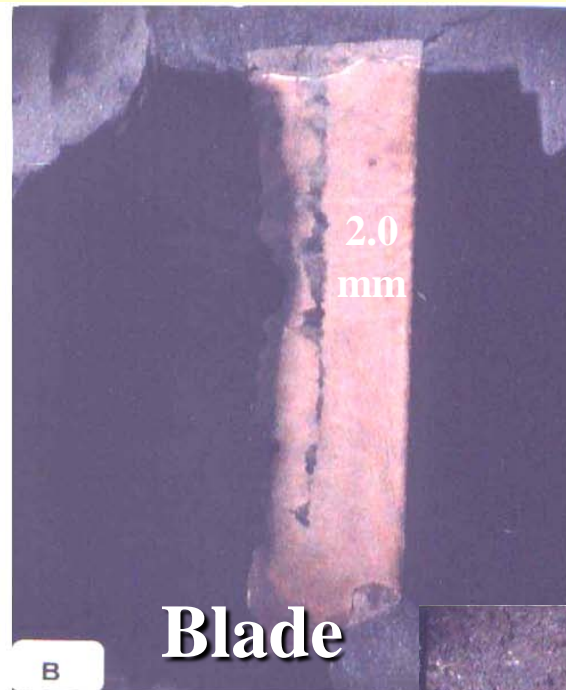
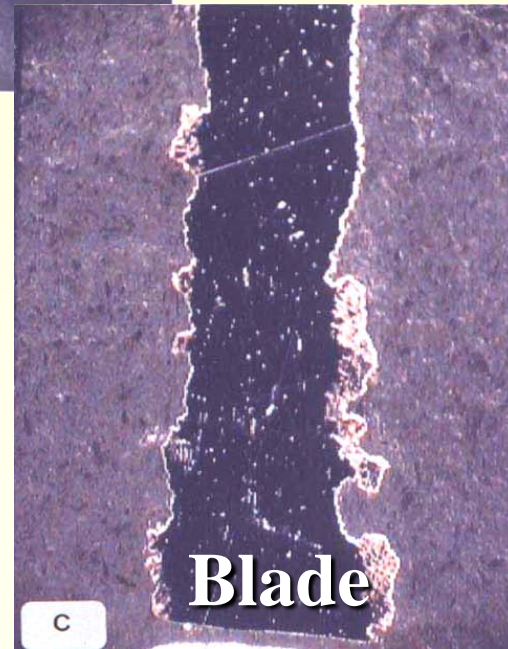
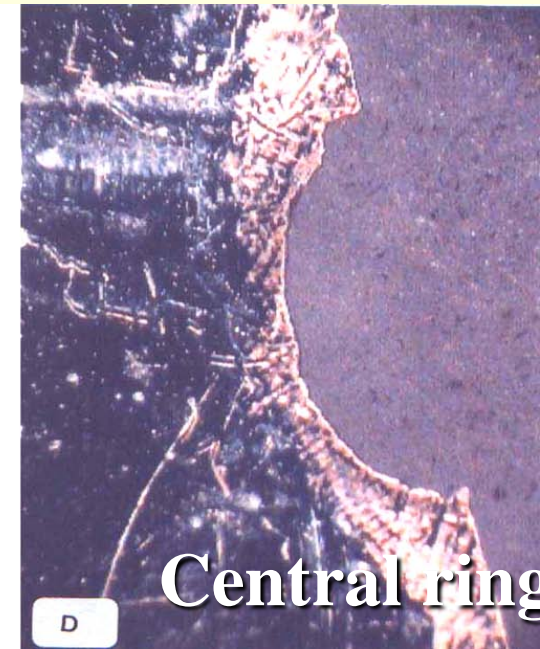
UNS C87500: 14.6%Zn, 3.75%Si

- Layer type dezincification
- Erosion of copper layer

- **Pink -copper rich layer.** Zinc and silicon disappeared and the remained area contained pure copper and had a porous microstructure.
- This layer had **porous structure and low microhardness**, and therefore, when appeared on the impeller's blade it exhibited poor mechanical properties and could **failed by erosion**.

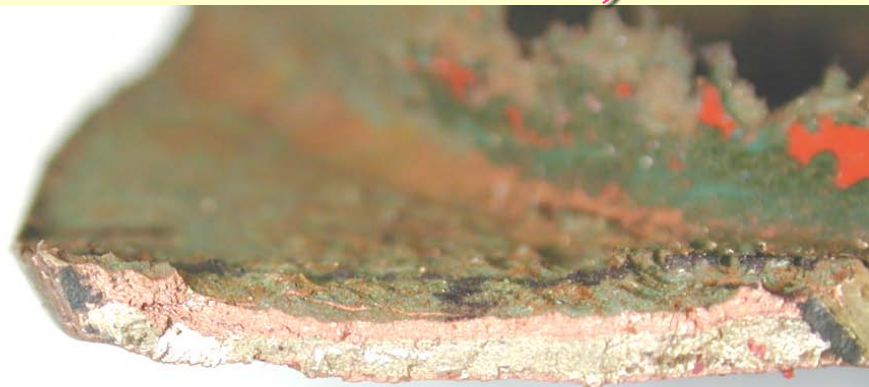
UNS C87600:6.6%Zn, 3.37%Si

**Edge of Failed Impeller
Blade:**

- COPPER LAYER**
- CRACKS BETWEEN
COPPER LAYER AND
UNCORRODED ZONE**

- Copper- rich zones on grain boundaries, having a pink color.
- Stress corrosion cracking was developed on the impeller's blade because of mechanical stresses, while dezincification without cracking was observed on the impeller's ring .
- The dezincification of this alloy containing low amount of zinc is attributed to the presence of higher amount of Si, in grain boundaries (>5%) as compared to the matrix (about 2 % Si)

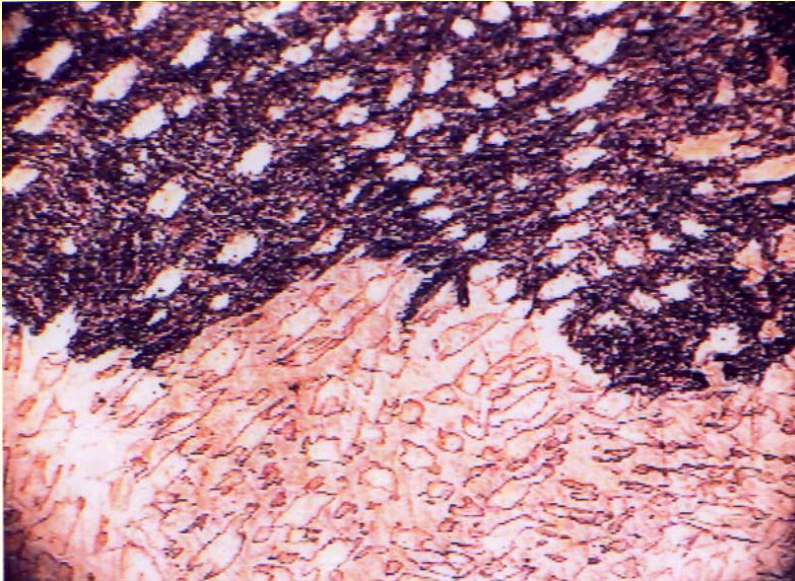
UNS C87500:

Copper layer

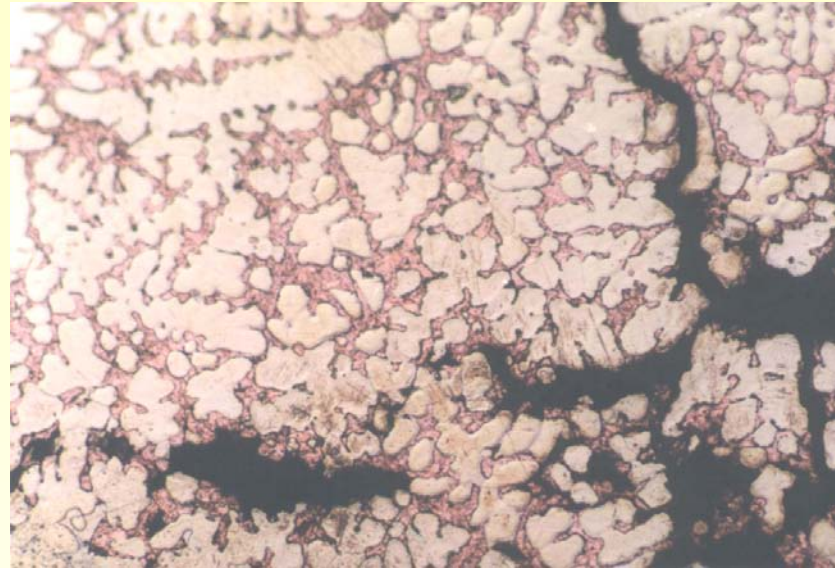
UNS C87600:

- Copper rich zones at grain boundaries
- Cracks at grain boundaries

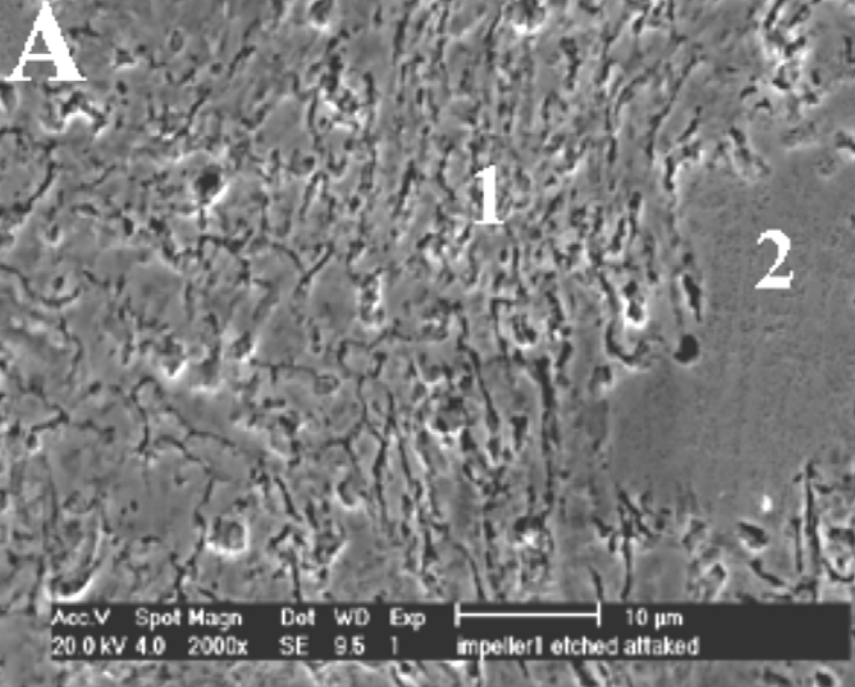
Corroded porous layer- copper layer

1	2
Si	0.3	3.2
Cu	99.6	82.9
Zn	0.1	13.9

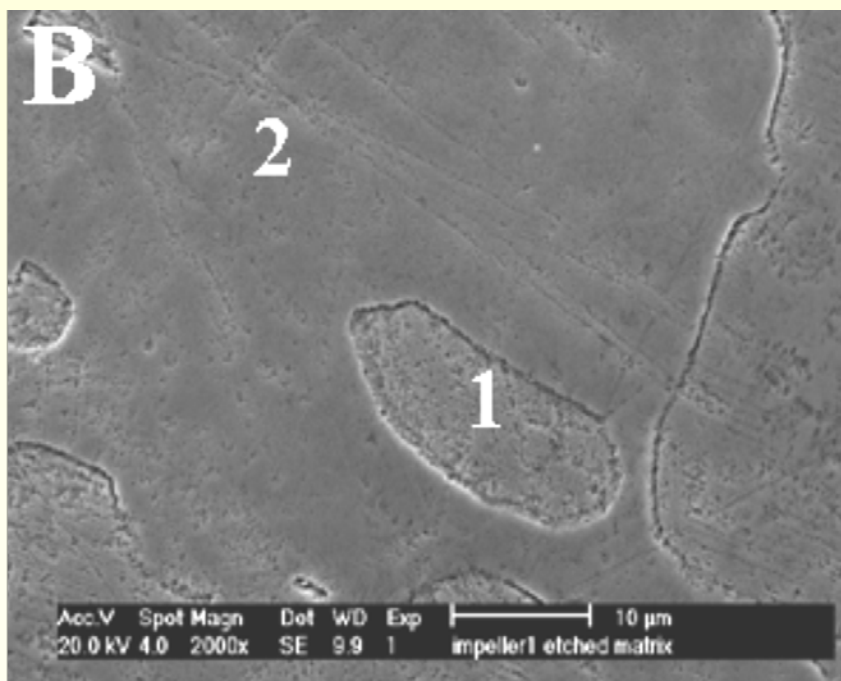
Near corroded layer – Difference in Si content

1	2
Si	3.6	5.4
Cu	83.2	81.3
Zn	13.3	13.4

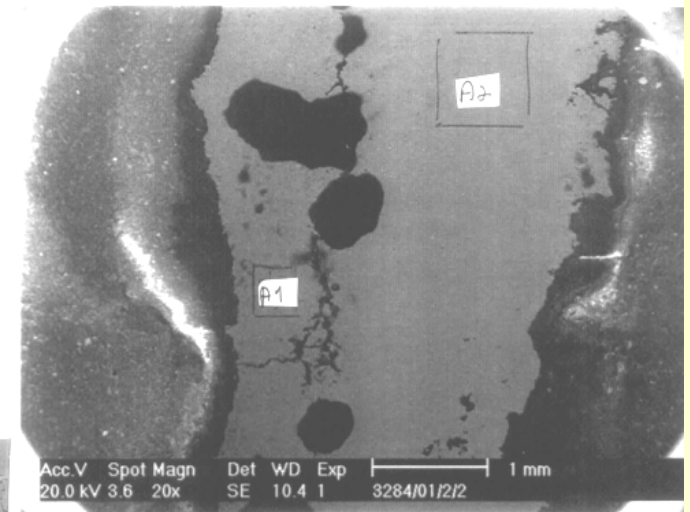
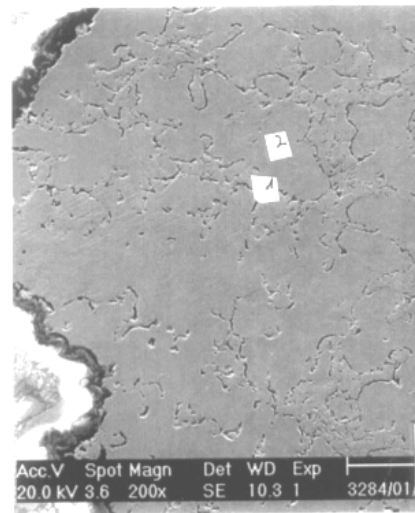
UNS C87600:6.6%Zn, 3.37%Si

Corroded area

- Copper rich zone on grain boundaries
- Cracks on grain boundaries

Near corroded layer

- Higher Si content in grain boundaries

A1	A2
Si	2.2	3.1
Zn	4.9	7.9
Cu	92.9	89.0
